# Mandatory Service Bulletin

**Topic:** Six-cylinder ignition rotor screw torque

**Models Affected:** 200-6XL (Lycoming style) and 200-6XC (Continental style) shipped prior to 8/28/21

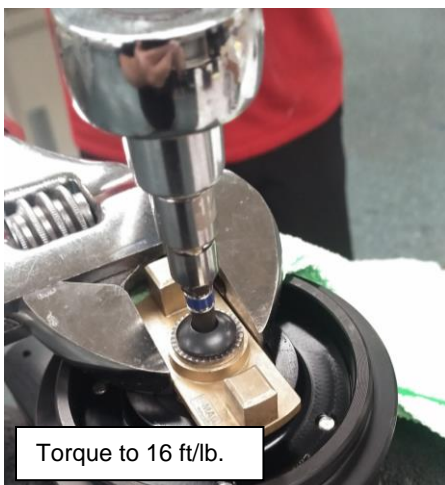
We've seen one instance where the screw holding the ignition drive rotor loosened after an extended period of operation. This allowed the drive rotor to vibrate against the shaft alignment splines and eventually spin on the shaft. We have reviewed the design for rotor attachment (rotor screw, locking ramp washers (2), shaft/rotor splines) and have re-confirmed the design is suitable for the task. It's impossible to rule out the possibility a process (torque) error during assembly may have played a role in the loosening occurrence.

Rotor screw torque is easy to check. It is accessible on the front (nose) end of the ignition – see pictures below. Torque rotor screw (3/16" allen-head) to 16 ft/lbs. No additional restraint (loc-tite, lock-washers, etc.) should be used.
