Mandatory Service Bulletin

Date: 12/1/23

Topic: Possible insufficient torque of sense-arm assembly screw.

Models Affected: 200-6XC (ignitions for Continental™ style engines). Thirteen (13) ignitions with serial numbers listed below.

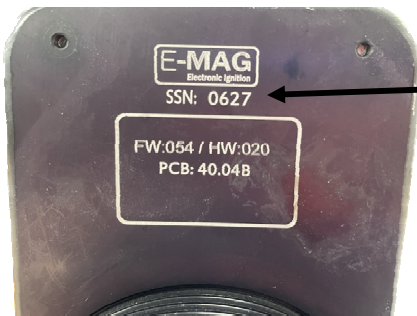
Identification: 200-6XC ignitions with the following serial numbers:
0832, 0833, 0834, 0835, 0857, 0855, 0856, 0857,
0858, 0992, 0993, 1019, 1020

A small batch of nose assemblies for 200-6XC ignitions may have insufficient torque applied to the internal sense-arm assembly screw. If this screw loosens, ignition operation could become inconsistent, rough, loose timing, or stop operating. Parts affected are internal to the ignition body.

Return to E-MAG for correction (no cost to customer).
